Wuhan University, China 21-22 November, 2008

**Research on
Deterioration of
Water Quality and Its Improvement
Caused by Dam Construction in Japan
~ Case Study of ISAHAYA Bay
Reclamation Project ~**

**Teiichi AOYAMA(青山貞一) Professor,
Faculty of Environment and Information Studies
Musashi Institute of Technology
(Specialty: Environmental Science and Policy**

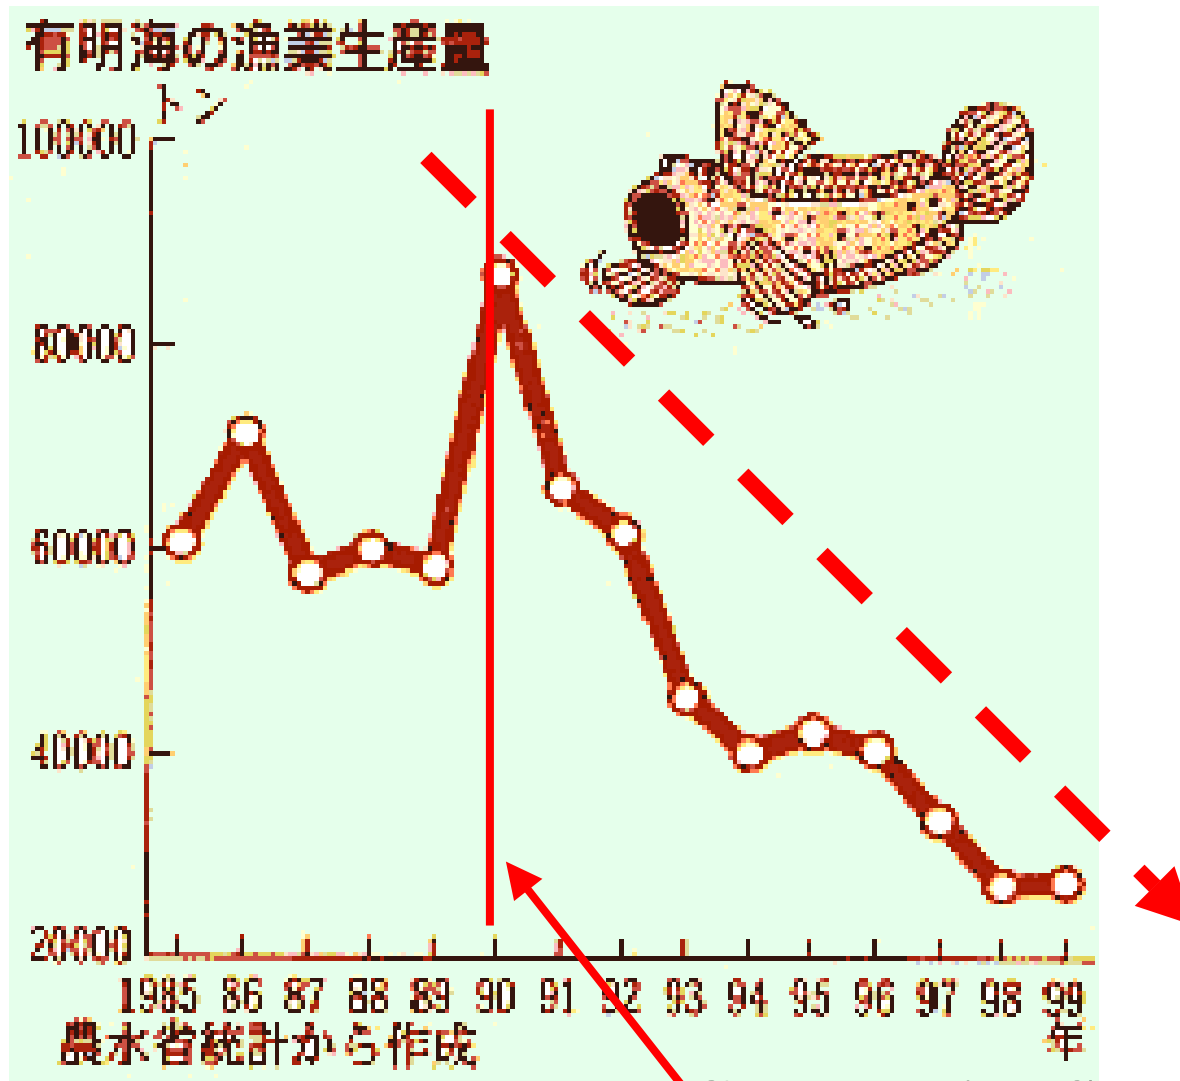
Trend of Fishery in ISAHAYA Bay from 1985 to 1999

This severe water quality damage caused the sudden **decrease of the fishery** in **ISAHAYA Bay** Area.

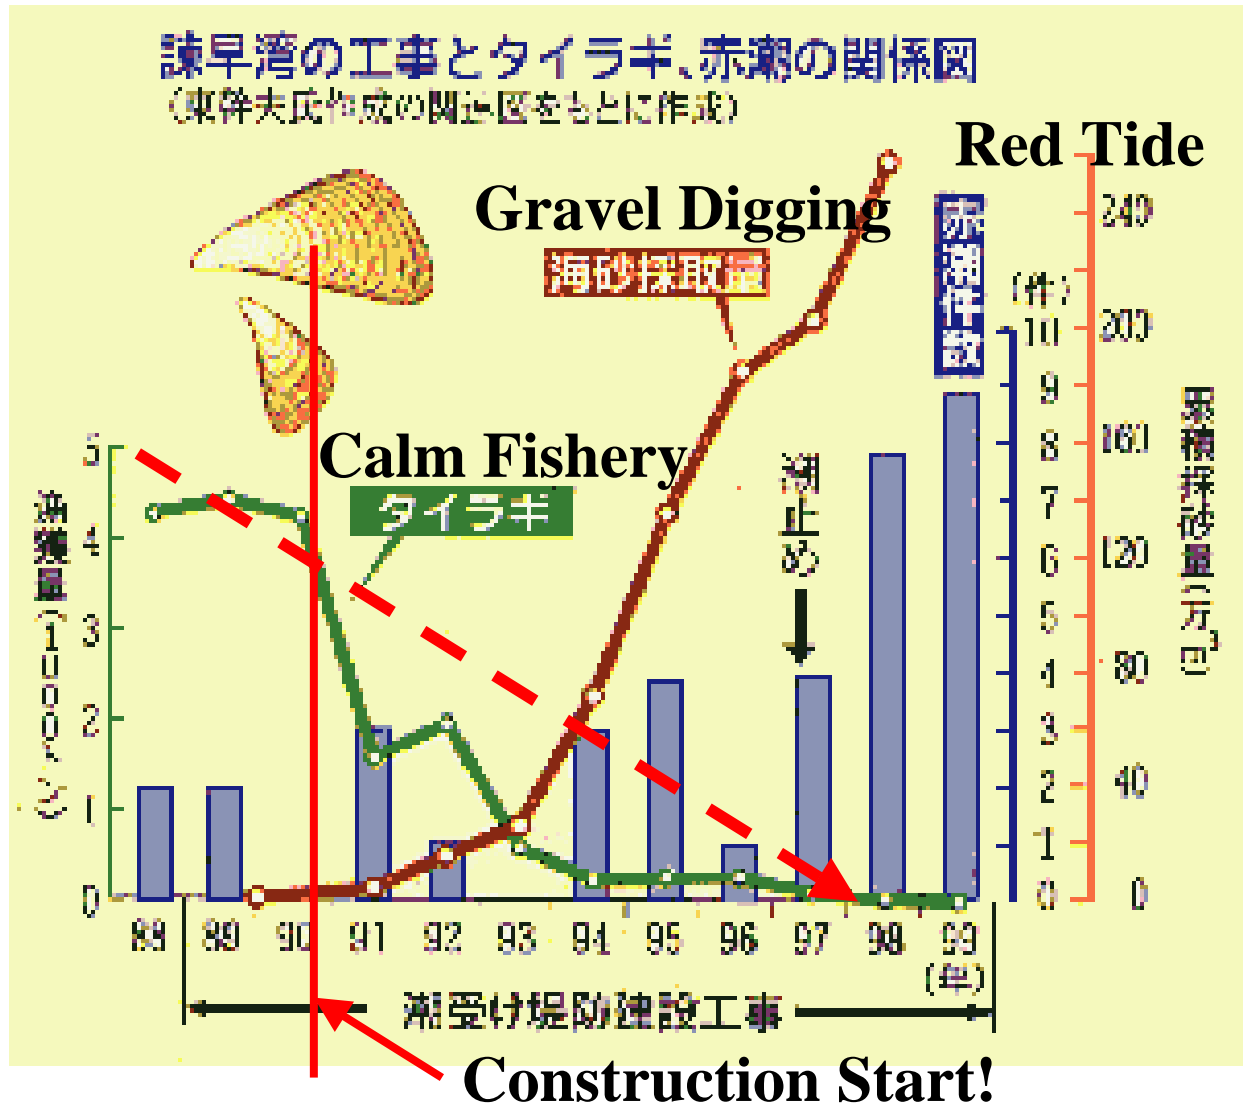
Trend of Shell (Tairagi) in ISAHAYA Bay from 1988 to 1999

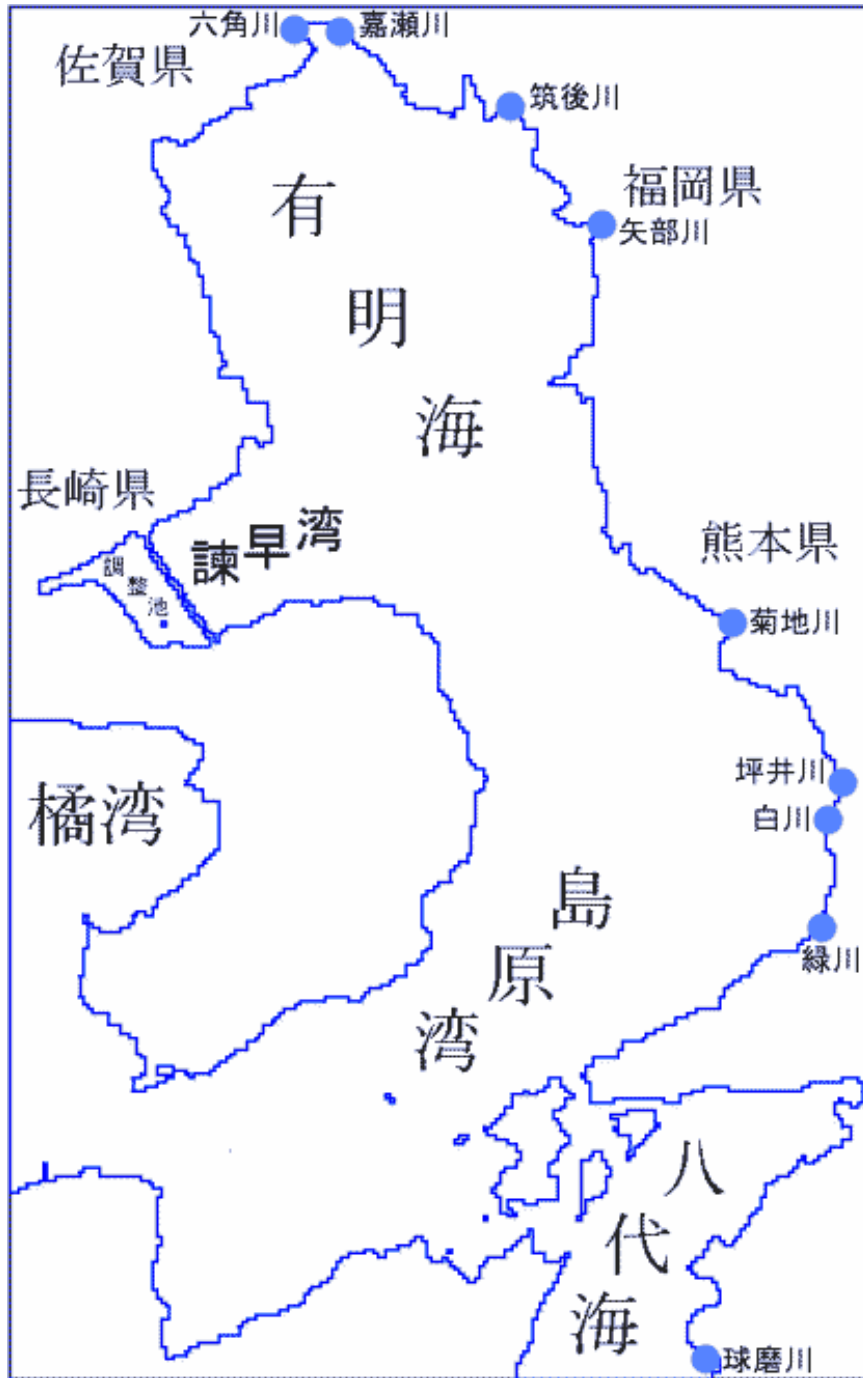
Target Sea Area of the Tidal Simulation

有明海
シミュレーション調査
対象範囲

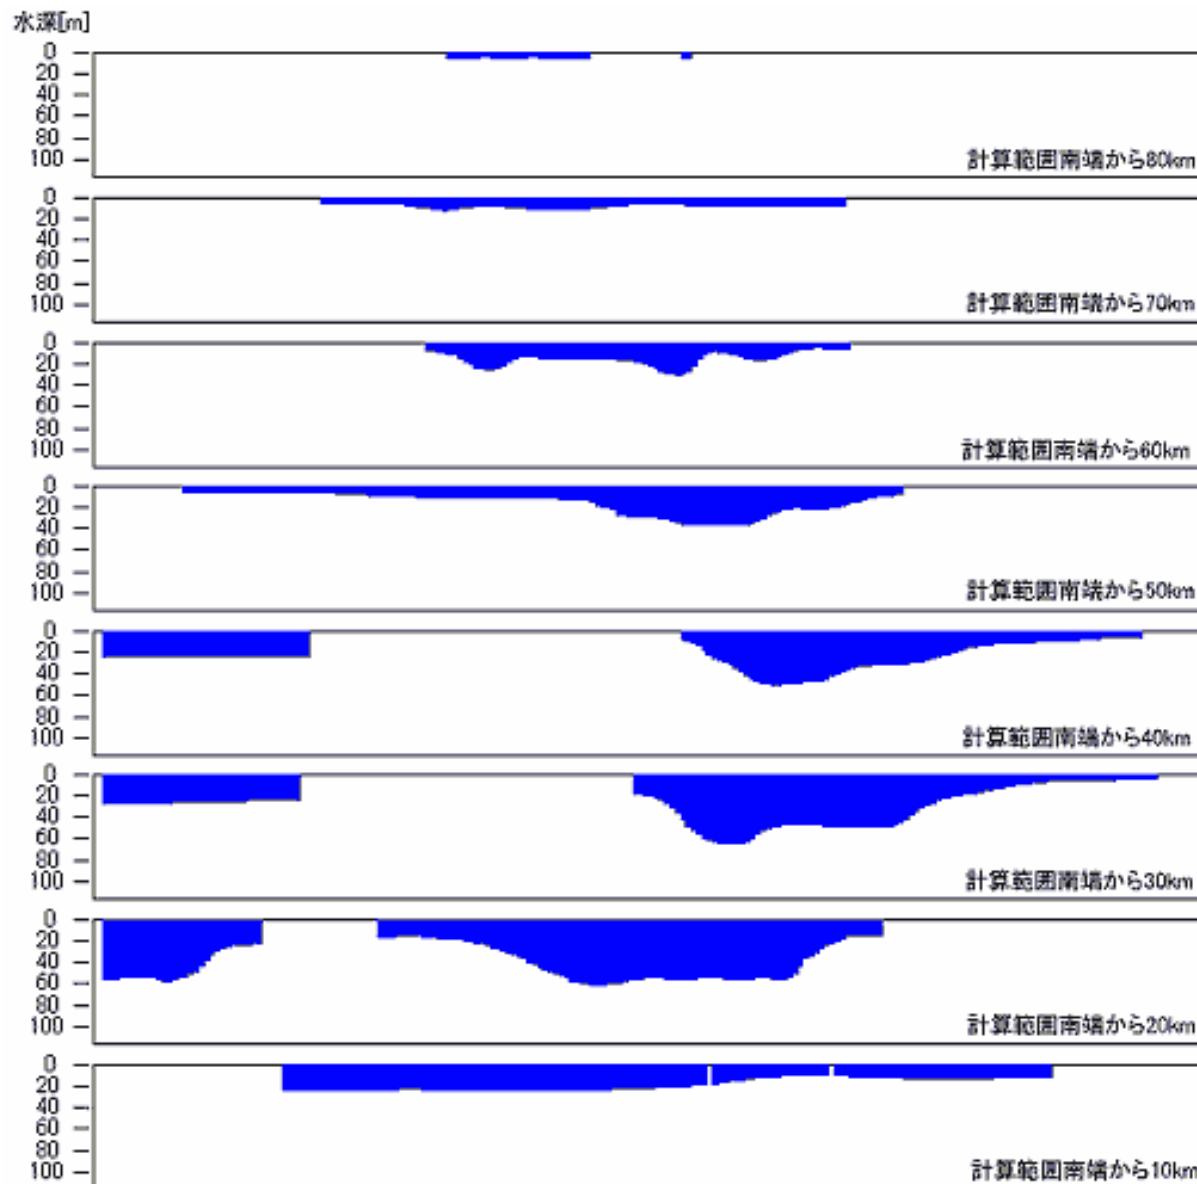
Oceanic Geographical Cross Section features of the Tidal Simulation 有明海海洋地形断面図
